DEPARTMENT OF TRANSPORTATION

Contract #: 04-0120F4Cty: SF/ALA Rte: 80 PM: 13.2/13.9File #: 78.28**WELDING INSPECTION REPORT****Resident Engineer:** Casey, William**Address:** 333 Burma Road**City:** Oakland, CA 94607**Report No:** WIR-030071**Date Inspected:** 24-Sep-2013**Project Name:** SAS Superstructure**OSM Arrival Time:** 1500**Prime Contractor:** American Bridge/Fluor Enterprises, a JV**OSM Departure Time:** 2330**Contractor:** Steward Machine Co.**Location:** Birmingham, AL**CWI Name:** Fred Hudson / Jimmy Brewer**CWI Present:** Yes No**Inspected CWI report:** Yes No N/A**Rod Oven in Use:** Yes No N/A**Electrode to specification:** Yes No N/A**Weld Procedures Followed:** Yes No N/A**Qualified Welders:** Yes No N/A**Verified Joint Fit-up:** Yes No N/A**Approved Drawings:** Yes No N/A**Approved WPS:** Yes No N/A**Delayed / Cancelled:** Yes No N/A**Bridge No:** 34-0006**Component:** E2 Shear Key Anchorages**Summary of Items Observed:**

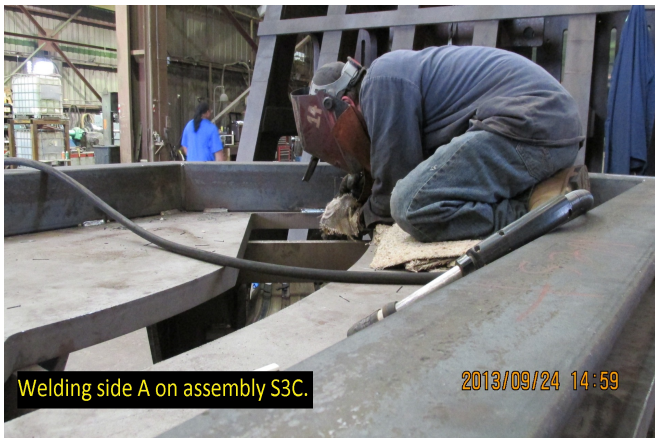
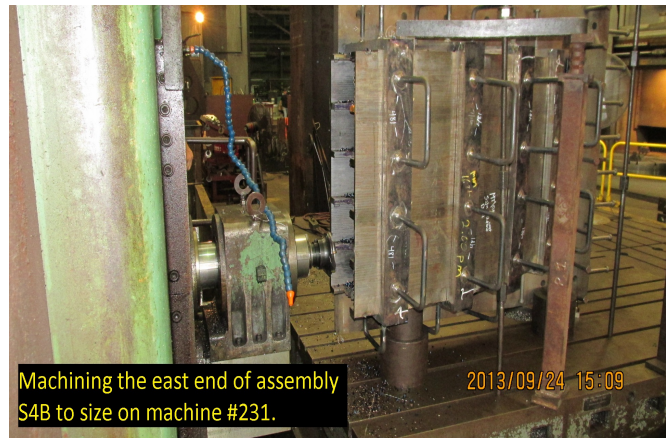
This QAI noted the s3 rods had been removed from the j3 plates, this was due to the rods being welded on in the wrong place. The j3 plates were also ground and the QC Inspector had performed MPT on these plates. This QAI then noted new s3 rods being welded back on the j3 plates. The welding was done by qualified welder John Roy (469). The welding was done to the approved welding procedure (WPS) P2-W126-B. All welding done was monitored by Certified Welding Inspector (CWI) Fred Hudson.

This QAI noted the above mentioned assembly had the sikadur applied and no other work was being done with this assembly at this time.
